**Report No SC14-2043 / 2**

## TESTING OF GUARD RAILS

It was requested to test a temporary handrail system (K2 modular system incorporating Master Clamp fittings and K Guard temporary system) to AS1657 Appendix B Section B4. As infill panels were not fixed, wind loading was not assessed.

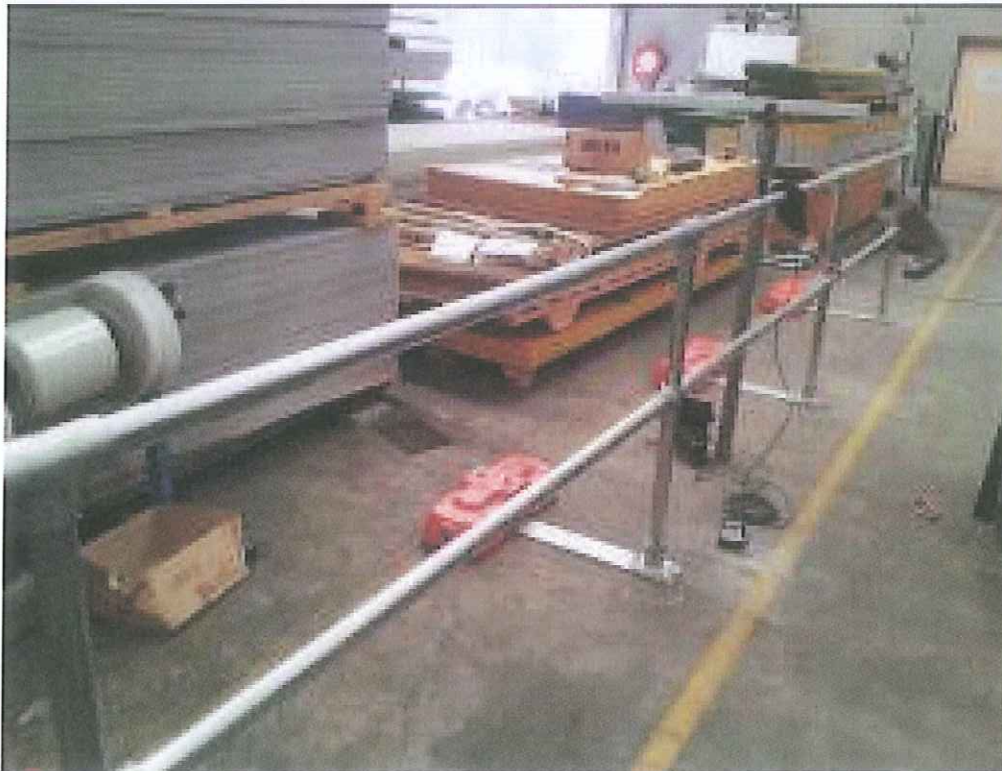
A fixed handrail section consisting of four posts fitted with a top and intermediate rail were set up as shown in Figure 1 (but with additional weights on the two end posts) with a span of 1850mm between posts.

The two end posts were loaded to 67kg on their base while intermediate posts were loaded to 29kg.

The middle upper rail was preloaded with a horizontal outward force of 324N and a datum established. A test load of 647.5N was then applied as a horizontal outward load and an elastic deflection of 33mm was recorded (under load) and 6.5mm permanent deflection, complying with the requirement of not exceeding 100mm and 20mm respectively.

An upward vertical datum force of 324N was applied to the rail and then the vertical test load of 647.5N was applied with 4mm elastic deflection recorded under load and 0.5mm permanent deflection, complying with the above requirements.

A horizontal ultimate load of 1295kN was applied and the system supported the load without collapse with 74mm permanent deflection, complying with the test requirement.
